## **Infrasound Assessment of Infrastructure**

### **Report 6: Scour Detection and Riverine Health Assessment Using Infrasound**

May 2016

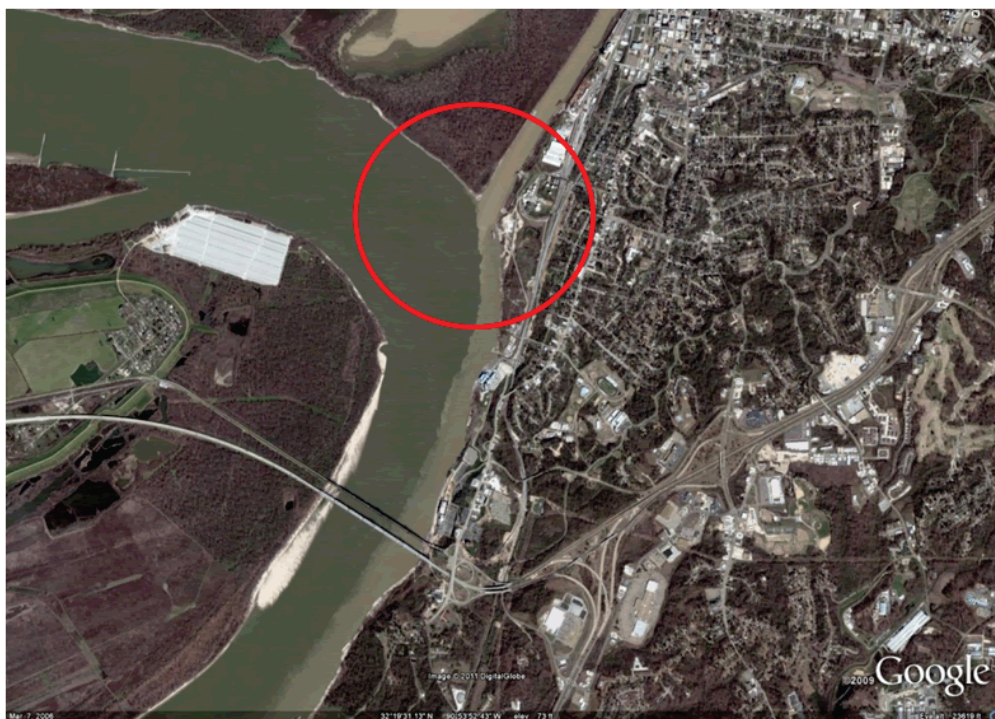
Figure 15. Previously unrecorded signal correlated to the confluence of the Yazoo Diversion Canal and the Mississippi River.

The DAMES Array at Vicksburg also detected a previously unrecorded signal that correlated to the confluence of the Yazoo Diversion Canal and the Mississippi River (Figure 15).

This signal appeared only after the Mississippi River had reached flood stage during the Mississippi River flood of 2011. It was initially hypothesized that this signal might correspond to the river equivalent of surf infrasound on the bend in the river and/or be a result of strong currents in the region from the increased flow volume and velocity (Garcés et al. 2006 and 2003). To confirm that this signal was actually a result of the flooding, infrasound data from two points in time were compared. Figure 16 shows the data from May 19, 2011. This date corresponds to the crest of the Mississippi River in Vicksburg, MS, during the flood of 2011, which was the highest stage on record.
